SARS-CoV-2 Superspread in Fitness Center, Hong Kong, China, March 2021

Appendix

Ventilation calculations

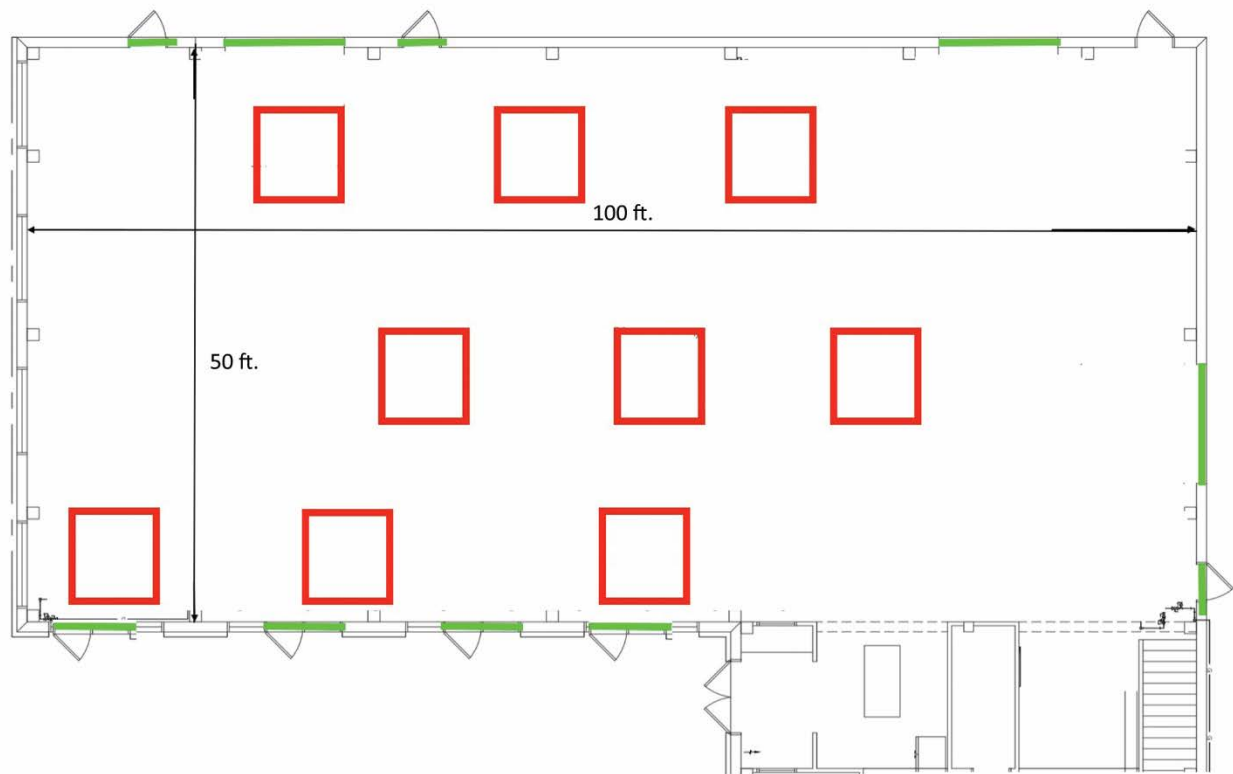
Appendix Figure 1. Diagram of interior of gym space that was part of investigation. Green lines indicate conventional and overhead garage doors that were at least partially open; red boxes indicate athlete workout stations.

The gym is a standalone building measuring 100 ft × 50 ft with an inclined, peaked ceiling 11.25 ft–19.75 ft high. The gym has 4 sets of double doors, 3 single doors, and 3 garage doors (Appendix Figure 1). The air change rate with the doors closed was estimated by the tracer gas concentration decay method when the gym was unoccupied, on the basis of measurements of CO₂. The ventilation rate was then calculated by multiplying the air change rate by the volume of the gym (3,593 m³). The volume flow rate through the gym with the doors open was estimated conservatively on the basis of the area through which air was exchanged by cross-ventilation through 4 single doors (total opening area 7.8 m²) on one side of the building and additional doors on the opposite side of the building, with a wind speed of 0.3 m/s, corresponding to the lowest average daily wind speed during January–May 2020. The tracer gas decay method could not be used to estimate the air change rate with the doors open because the building could not be left unoccupied with the doors open for the required duration of ≥ 2 h. The direction of flow through the gym varied with the direction of the wind.
